FIVE-YEAR REVIEW REPORT

**Pinette's Salvage Yard Superfund Site
Washburn, Maine**

September 2000

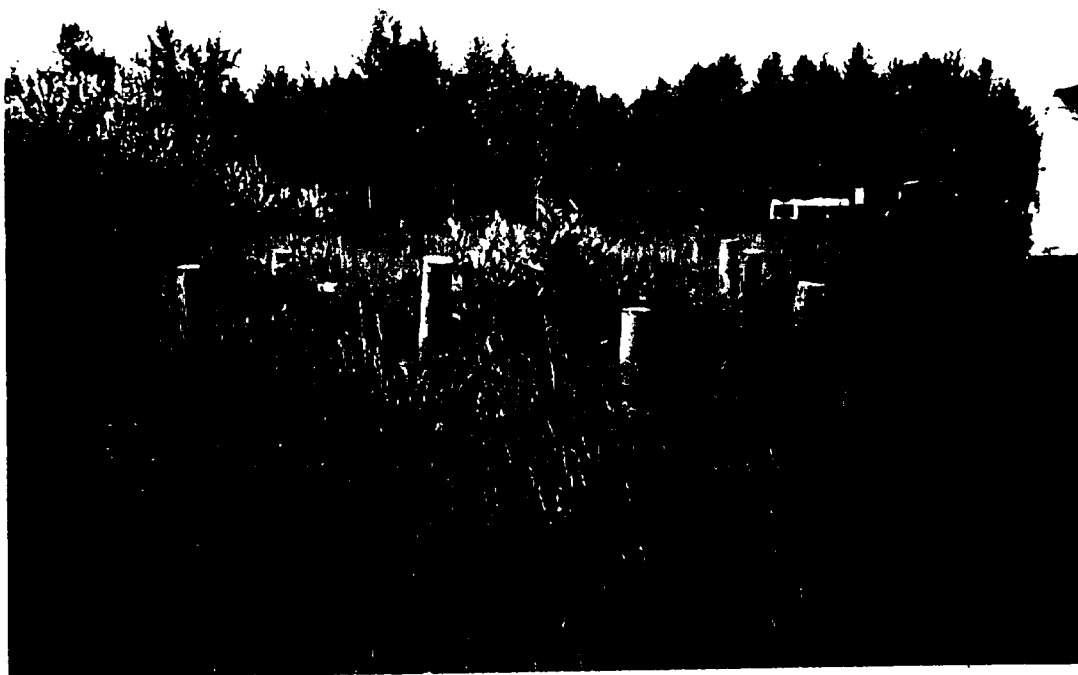
MW-5 cluster with northern fence line in background.

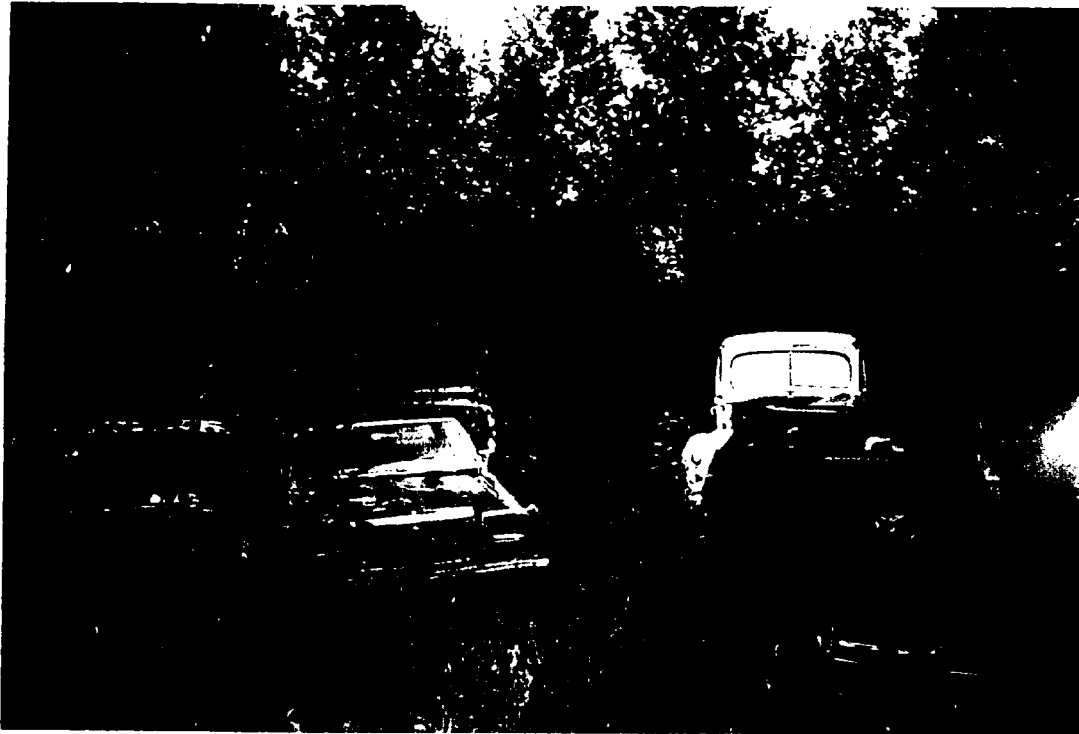
MW-1 cluster area (wells obscured by tall grass).

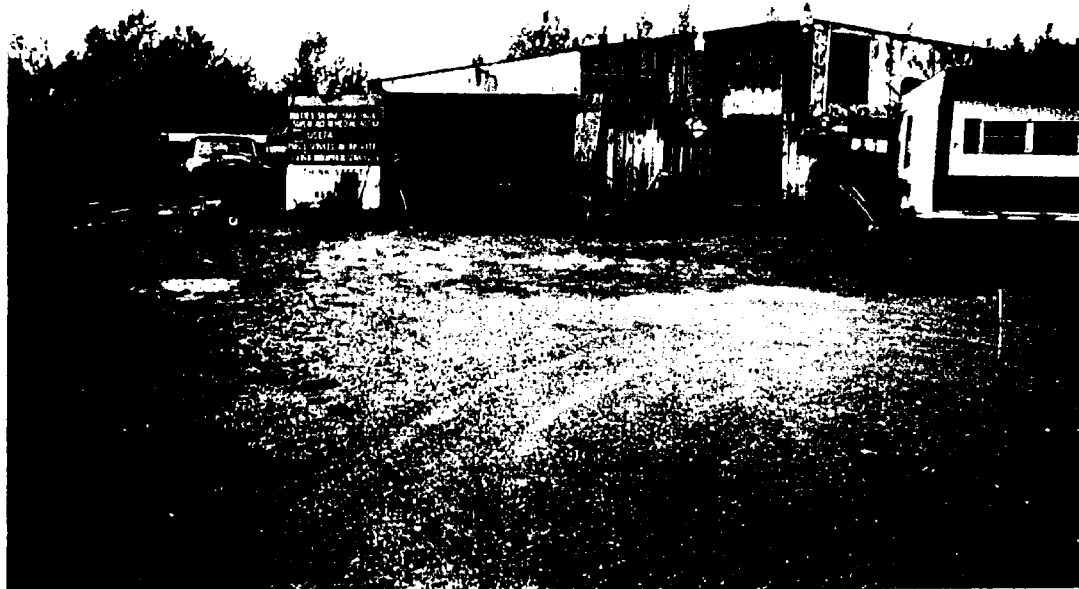
Roger Pinette's garage with old site sign used as siding.
